Manhole Inspection Summary

Manhole # S15AA_010MH

Location Address: **1006 ASHBURTON ST**

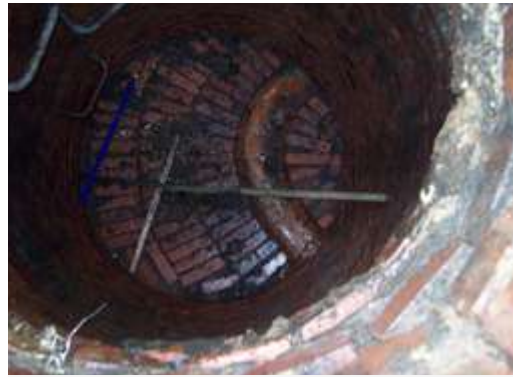
Top View

Condition: ☐ Sound ☐ Cracked ☐ Root Intrusion ☐ Deteriorated ☐ Leaks ☒ **Debris**

CHANNEL DEBRIS

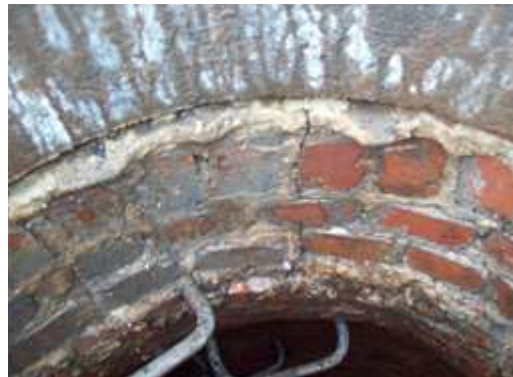
Defect 1

Condition: ☐ Sound ☒ **Cracked** ☐ Root Intrusion ☐ Loose Brick ☐ Deteriorated

CRACKED CORBEL

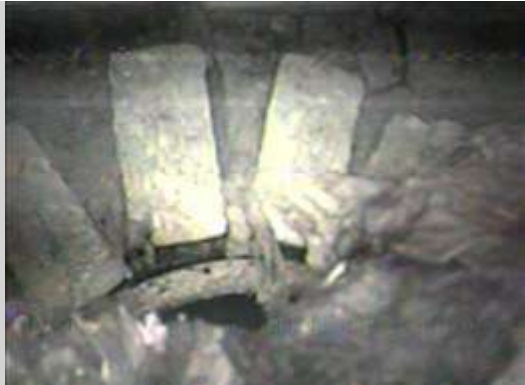
12 O'Clock Outflow

10 in. Circular Gravity Sewer
Pipe Out @ 12 O'Clock

Pipe Height: (in.) Direct
Pipe Material: **Clay** ☐ Pipe Lined
Invert Depth: **9.28** (ft.) Flow Characteristics: **Slow**
Deposits: ☐ None ☒ Mud ☒ Sludge ☒ Debris ☒ Grease
Silt Depth: **3** (in.) Deposits Extent: **Heavy**
Infiltration: **None** Pipe Seal Cond: **Unknown**

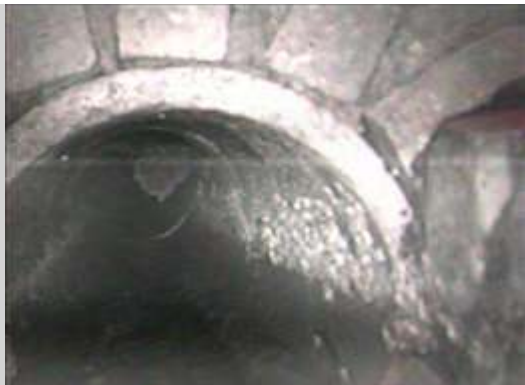
3 O'Clock Inflow

10 in. Circular Gravity Sewer
Pipe In @ 3 O'Clock

Pipe Height: (in.) Direct
Pipe Material: **Clay** ☐ Pipe Lined
Invert Depth: **8.87** (ft.) Flow Characteristics: **Slow**
Deposits: ☒ None ☐ Mud ☐ Sludge ☐ Debris ☐ Grease
Silt Depth: (in.) Deposits Extent:
Infiltration: **None** Pipe Seal Cond: **Sound**
